North Cascade Home Inspection LLC.

Property Inspection Report

Property address: **555 front st**

Inspection date: **Saturday, April 20, 2013**

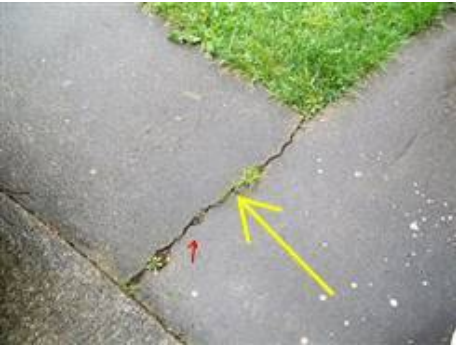
**Photo 4-1**

Minor deterioration in the way of cracks was found in the sidewalk on the east side, but no trip hazards were found. The client may wish to have repairs made for cosmetic reasons.

Crack in concrete sidewalk on east side

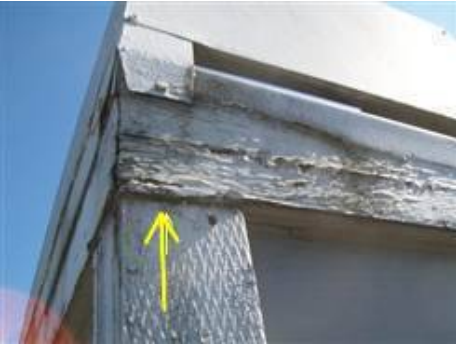
**Photo 6-1**

The paint on the north side of the chimney trim has failed. I recommend that a qualified contractor clean and paint the trim to protect it from the weather.

Chimney paint deteriorated

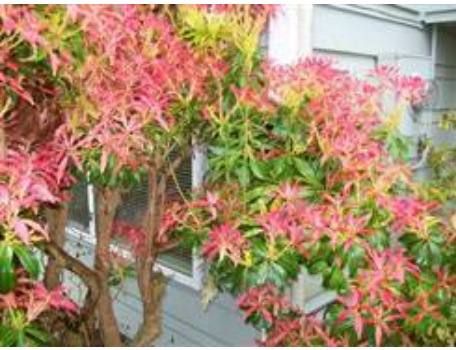
Vegetation such as trees, shrubs and/or vines was in contact with or close to the building exterior. Vegetation can serve as a pathway for wood-destroying insects and can retain moisture against the exterior after it rains. This is a conducive condition for wood-destroying organisms. Recommend pruning, moving or removing vegetation as necessary to maintain at least 6 inches of space between it and the building exterior. A 1-foot clearance is better.

Photo 7-1
Vegetation on north side

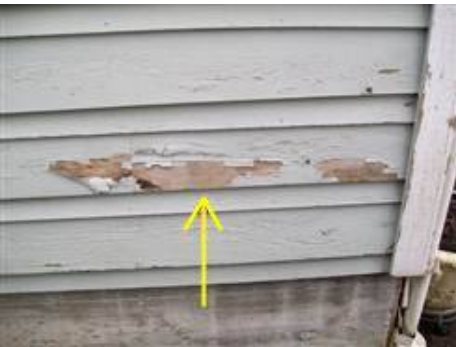
Photo 8-1

The siding on the south side of the house has worn or deteriorated paint and wood is exposed to the weather. Recommend prepping and painting the siding and trim as necessary to protect.

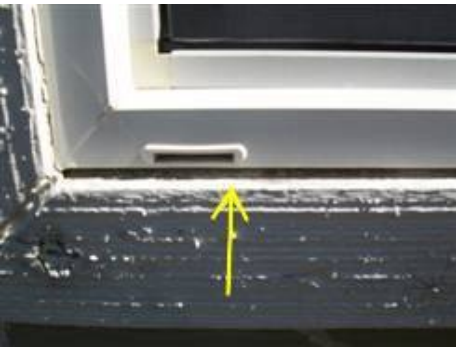
Photo 10-1

- 10) The caulking around the window trim on the south side windows is cracked and missing in some spots. I recommend that a qualified contractor caulk the areas so they are sealed to the weather.
